Case No. 1:14-cv-737-CL

**THIRD DECLARATION OF
THERESA L. SIMPSON**

In Support of Plaintiffs' Opposition to
Defendants' Motion to Dissolve
Injunction

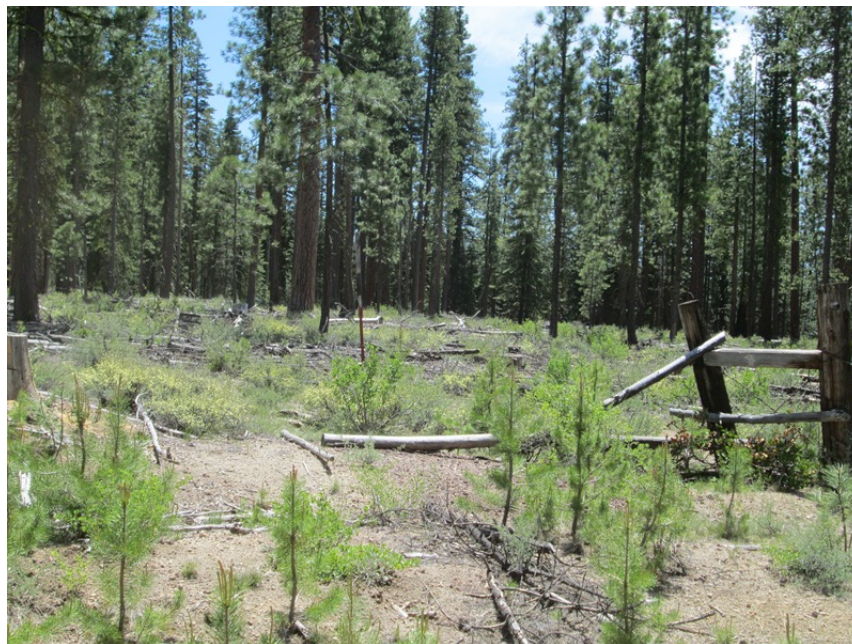
5. The following photo shows the Boundary fence between the Chemult Pasture and North Sheep Pasture down with a broken H brace and all four wires on the ground at the cattleguard on Road 8829.

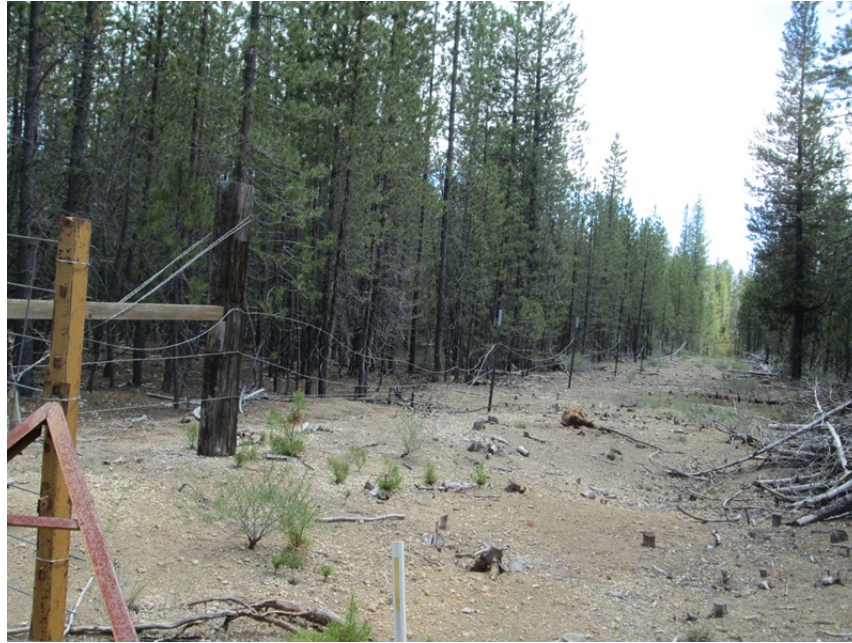
6. The following photo shows the fence between Jack Creek pastures and Chemult Pasture (aka frog fence) with broken, unclipped and sagging wires on the fence at cattleguard on Road 9814:

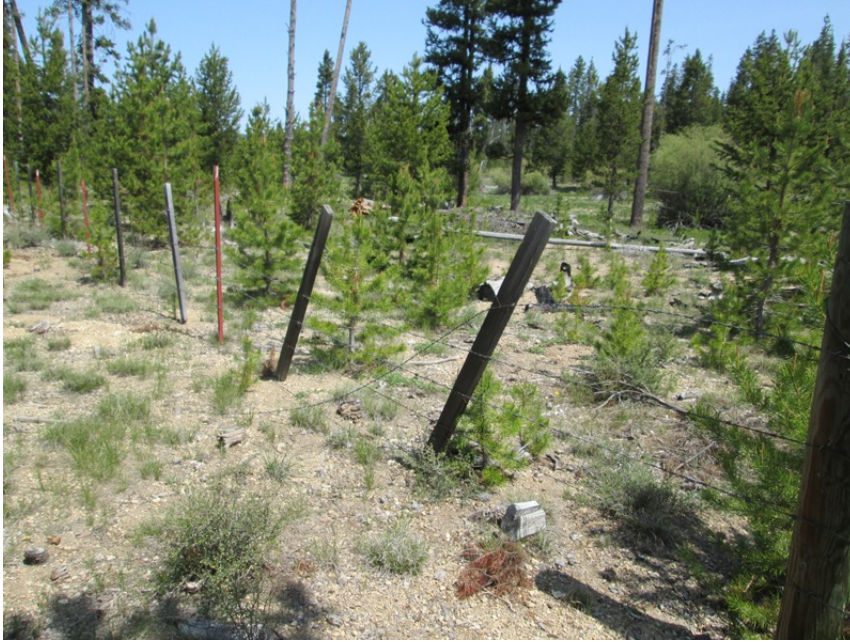
8. The following photo shows broken, sagging wires on the Dry Meadow exclosure fence in the Chemult Pasture:

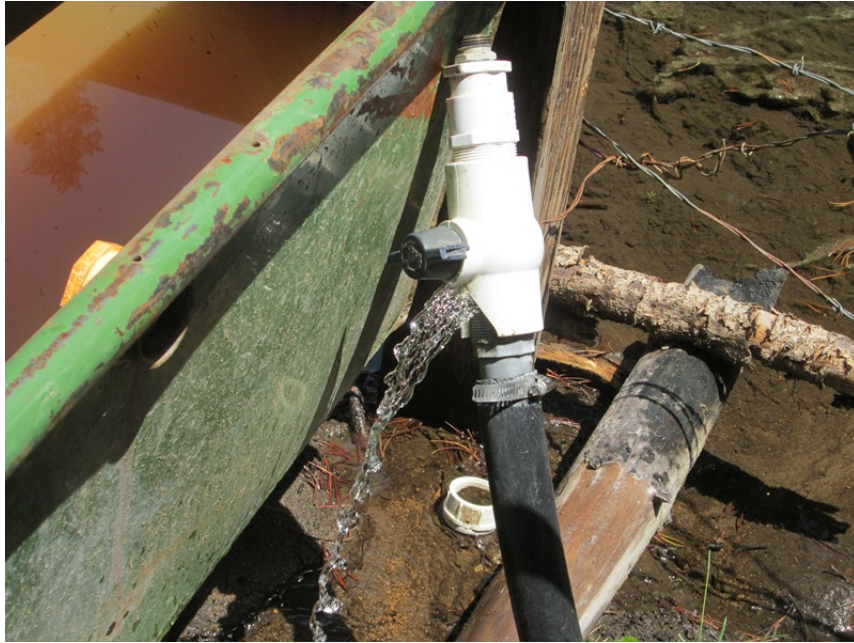
11. The following photo in the Chemult Pasture shows a broken valve/stream of water draining the fen at the unmaintained Sproats Meadow trough:

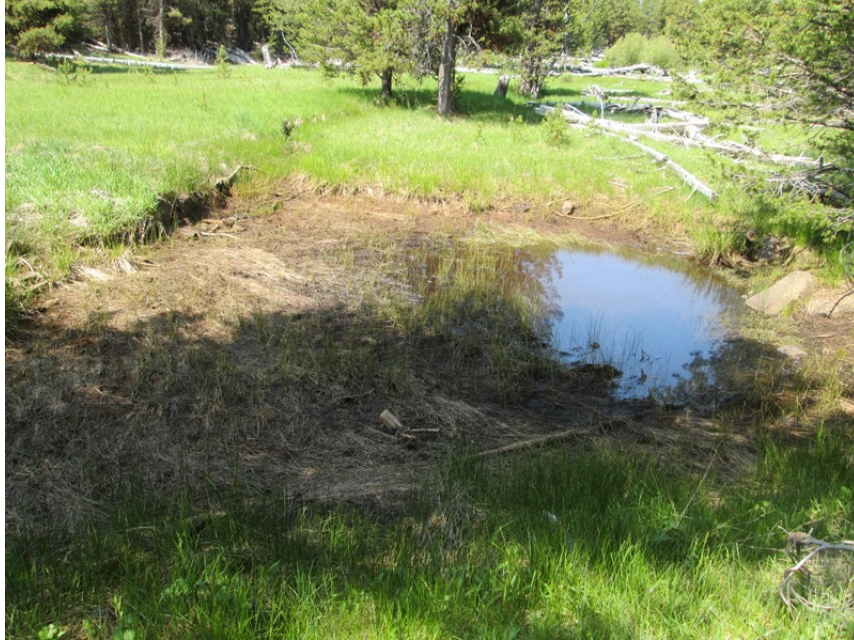
16. The following photo shows the water chance in the fen is nearly empty at Squirrel Camp in the Chemult Pasture:
